Manhole Inspection Summary

Manhole # S49GG_007MH

Insp Date: **8/7/08 9:14 AM**

Location Address: **Kenwood**

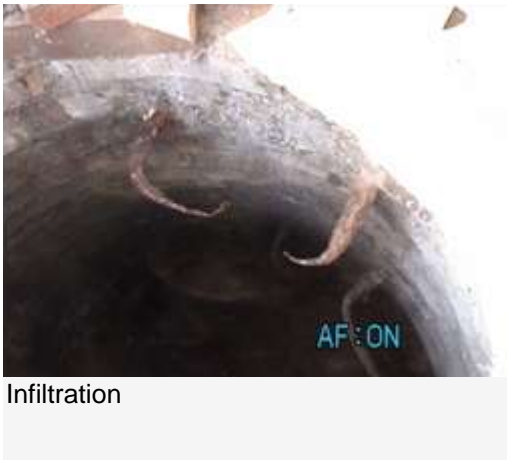
Defect 1

Condition: ☐ Sound ☐ Cracked ☐ Root Intrusion ☒ **Loose Brick** ☐ Deteriorated

Infiltration: ☐ None ☒ **Joint** ☐ Cracks ☒ **Mortar** ☐ Roots ☒ **Wall**

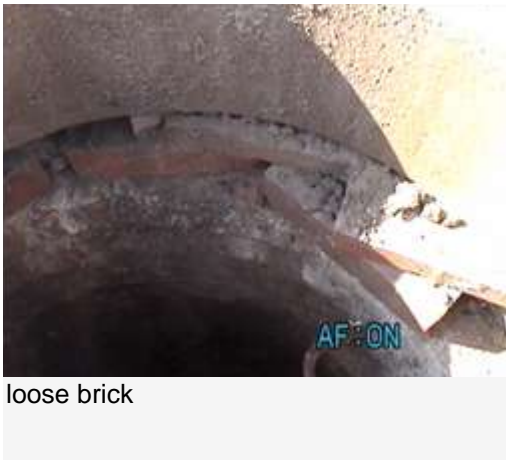
Defect 2

Count: **4** Missing: **2** ☒ **Corroded**

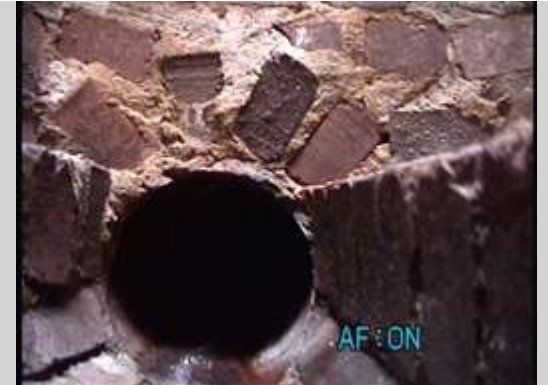
12 O'Clock Outflow

8 in. Circular Gravity Sewer
Pipe Out @ 12 O'Clock

Pipe Height: **8.4** (in.) Rod and Bar (Angled)
Pipe Material: **Clay** ☐ Pipe Lined
Invert Depth: **8.80** (ft.) Flow Characteristics: **Fast**
Deposits: ☒ None ☐ Mud ☐ Sludge ☐ Debris ☐ Grease
Silt Depth: (in.) Deposits Extent:
Infiltration: **None** Pipe Seal Cond: **Sound**

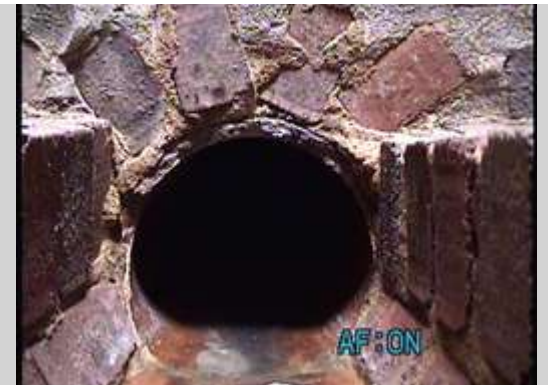
6 O'Clock Inflow

8 in. Circular Gravity Sewer
Pipe In @ 6 O'Clock

Pipe Height: **8.4** (in.) Rod and Bar (Angled)
Pipe Material: **Clay** ☐ Pipe Lined
Invert Depth: **8.60** (ft.) Flow Characteristics: **Fast**
Deposits: ☒ None ☐ Mud ☐ Sludge ☐ Debris ☐ Grease
Silt Depth: (in.) Deposits Extent:
Infiltration: **None** Pipe Seal Cond: **Sound**

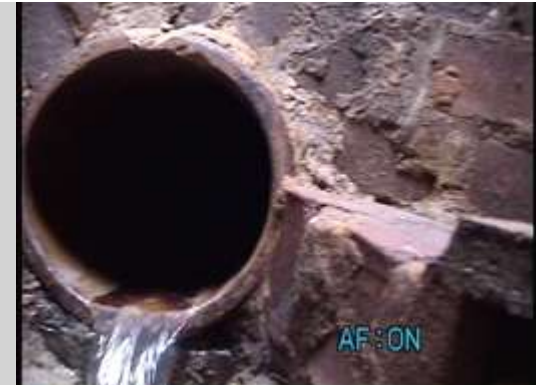
9 O'Clock Inflow

8 in. Circular Gravity Sewer

Pipe In @ 9 O'Clock

Pipe Height: **8.4** (in.) Rod and Bar (Angled)

Pipe Material: **Clay** ☐ Pipe Lined

Invert Depth: **8.10** (ft.) Flow Characteristics: **Fast**

Infiltration: **None** Pipe Seal Cond: **Sound**
